RCA-56-22-001-1: Insufficient Hood Adhesive

Document Type	Customer Satisfaction Campaign Bulletin
Date	January 13, 2022
Affected Region(s)	USA
Affected Model(s)	R1T
Model Year(s)	2022
Approximate Build Dates Refer to the FSA Dashboard to determine if this document applies to a specific vehicle.	August 2021 - October 2021
Vehicle System	56 - Body
Minimum Service Location	Mobile

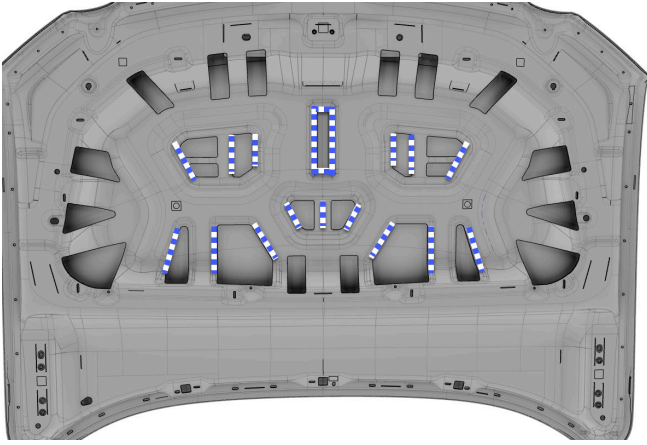
Rivian is initiating a customer satisfaction campaign for some model year 2022 R1T vehicles that may have been built with hood mastic adhesive that does not entirely bond the outer hood to the inner hood. If the outer hood is not correctly bonded to the inner hood, fluttering may be observed while driving at speeds of 70+ mph. Rivian is launching this campaign for customer satisfaction and to improve the quality of Rivian vehicles.

2. Inspect the adhesive in the paths shown. Apply additional adhesive as needed to secure the inner and outer hood.

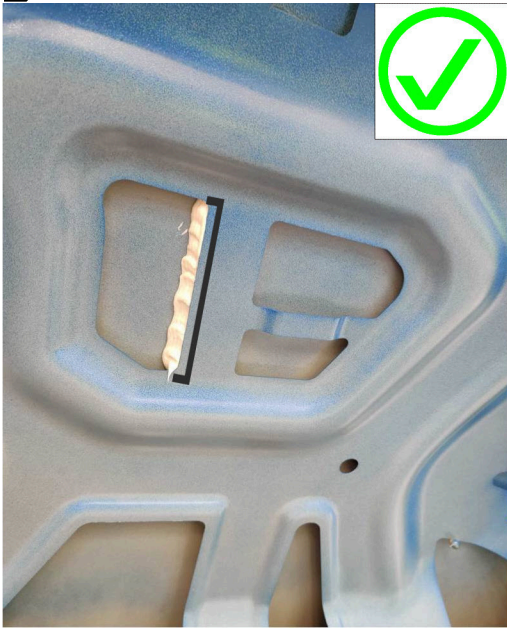
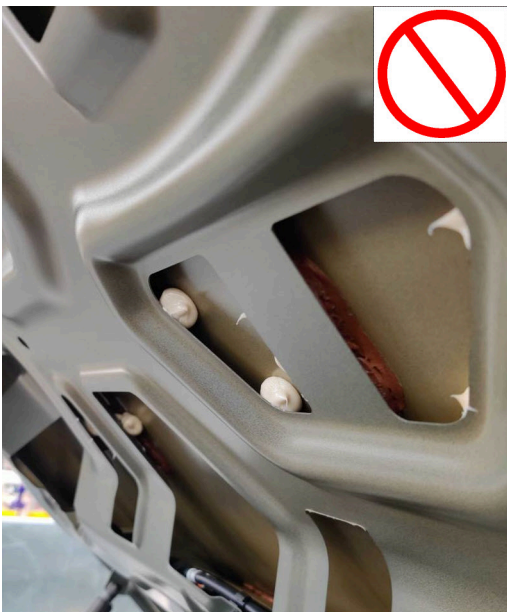
**Note:** Make sure that the adhesive is present along the entire path.

3. Wipe away all excess adhesive.
4. Reinstall all components that were removed for access.
