| Tesla, Inc. Service Bulletin | | <h2>Replace Front Fascia Harness and Front Fascia Camera</h2> | |
| SB-25-17-012 February 18, 2026 | | | |
| Model Y | 2025+ | North America | Fremont, Giga Texas |

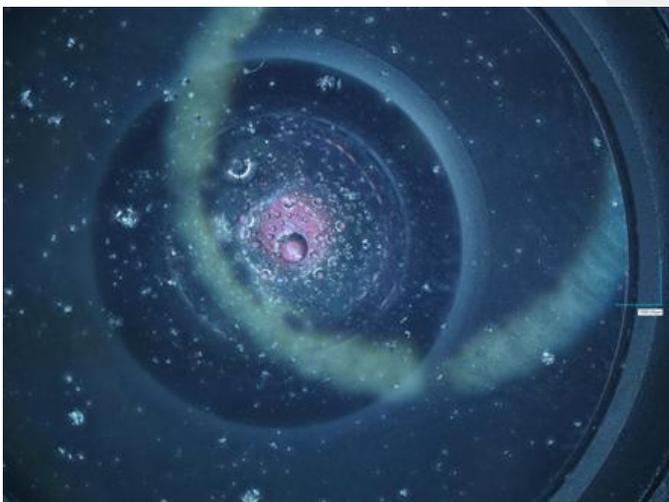
3. Remove the front fascia camera (refer to Service Manual procedure [1722010011](#)).
4. Use an LED flashlight to inspect the front fascia camera lens and connector for any signs of water ingress or corrosion (Figures 2 and 3).
 - If any signs of water ingress or corrosion are present, replace both the front fascia camera and the front fascia harness (refer to Service Manual procedures [1722010012](#) and [1710040202](#)), then skip to step 11.
 - If no signs of water ingress or corrosion are present, proceed to step 5.

Figure 2: Water inside of camera

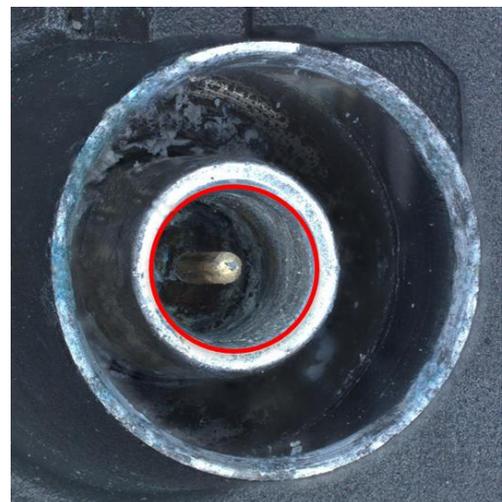
Figure 3: Corrosion on connector and wall

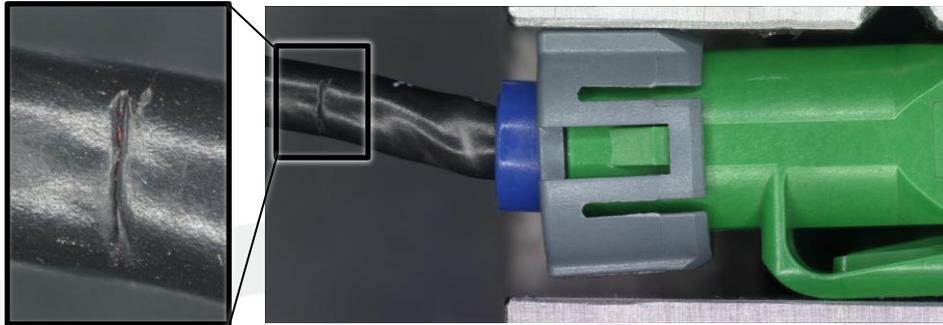
Figure 8

8. Inspect the harness for signs of abrasion or water ingress (Figures 8 – 11).

- If any signs of abrasion or water ingress are present, replace both the front fascia camera and front fascia harness (refer to Service Manual procedures [1722010012](#) and [1710040202](#)), then skip to step 11.
- If no damage or water ingress is present on the harness, reinstall the corrugated tubing onto the harness and wrap the end of the tube near the camera connector with electrical tape.
