| Tesla, Inc. Service Bulletin | | <h2>Replace Front Fascia Harness and Front Fascia Camera</h2> | |
| SB-25-17-012 February 18, 2026 | | | |
| Model Y | 2025+ | North America | Fremont, Giga Texas |

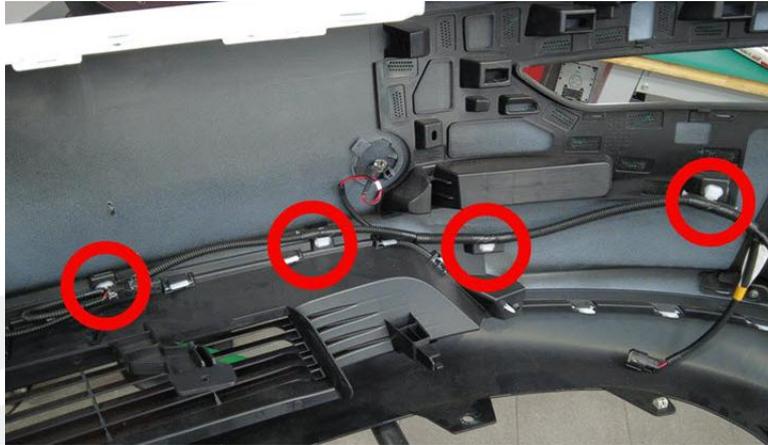
Figure 4

5. Remove the front fascia (refer to Service Manual procedure [1001020501](#)).
6. Remove the camera connector branch of the front fascia harness from the fascia.
 - a. Remove the fir-tree clips (x4) that attach the camera connector branch of the front fascia harness to the fascia (Figure 4).

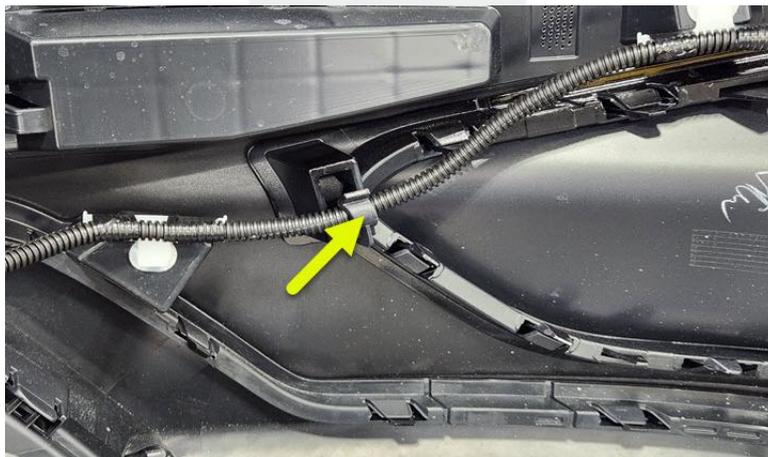
Figure 5

- b. Release the camera connector branch of the front fascia harness from the hook (Figure 5).

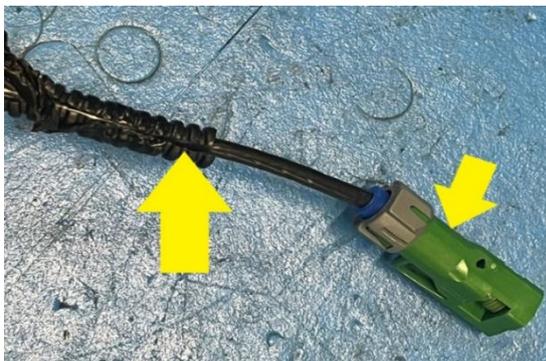
Figure 6

7. Peel the tubing off of the entire branch of the front fascia harness with the green coaxial connector (Figures 6 and 7).
